## **RESTORATION OF THE CUPOLA OF THE FIRST BAPTIST CHURCH SOUTH STREET - PITTSFIELD, MA**

**PROJECT CLIENT: Cenaxo**

**Dates of Performance: 06/01/2017 - 07/01/2017**

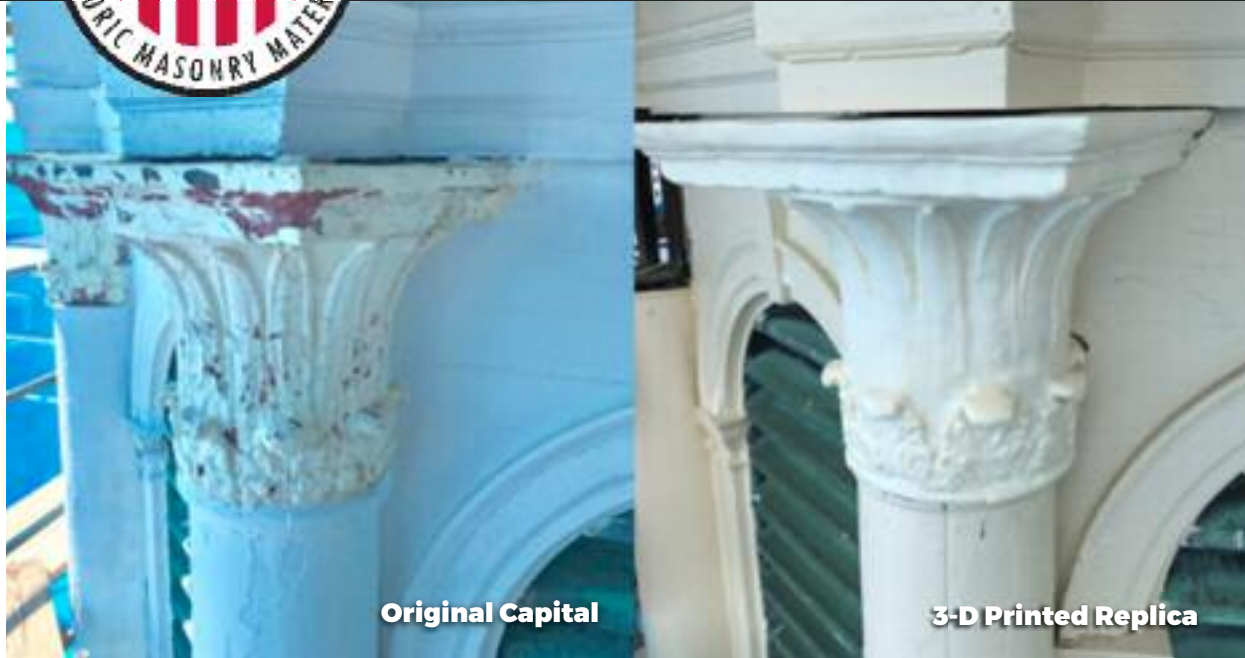
**Original Capital**

**3-D Printed Replica**

The restoration firm Cenaxo was hired to complete the extensive cupola restoration on the historic First Baptist Church in Pittsfield, Massachusetts. The scope included significant carpentry repairs, as well as painting the wooden and steel structure. As the project was nearing completion, an unforeseen condition jeopardized the completion of the project. It was discovered that the original composite capitals were severely deteriorated and could not be salvaged. Freedom Cement was brought in to utilize their scanner and 3-D printer to print a replica unit that was then utilized to create a new mold replicating the original capital details. The new mold was then utilized to cast eight new Microcotta ([www.microcotta.com](http://www.microcotta.com)) units. From start to finish, the process was completed within three weeks, and the scaffolding was removed in accordance with the original project schedule.

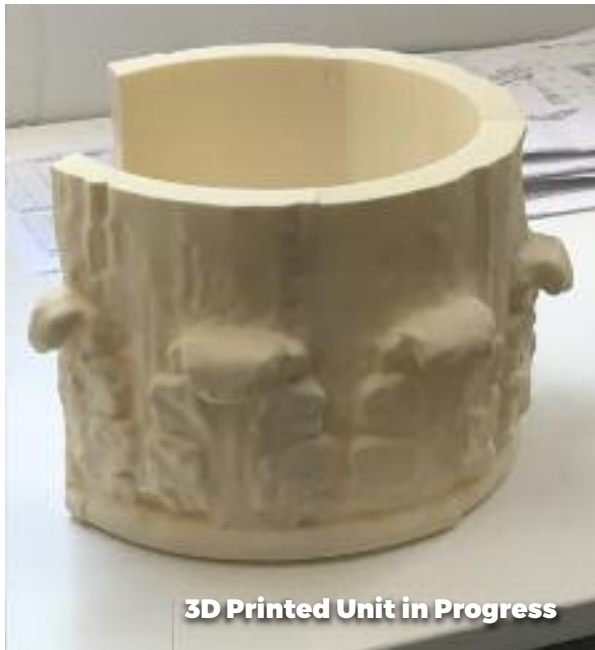
**3D Printed Unit in Progress**

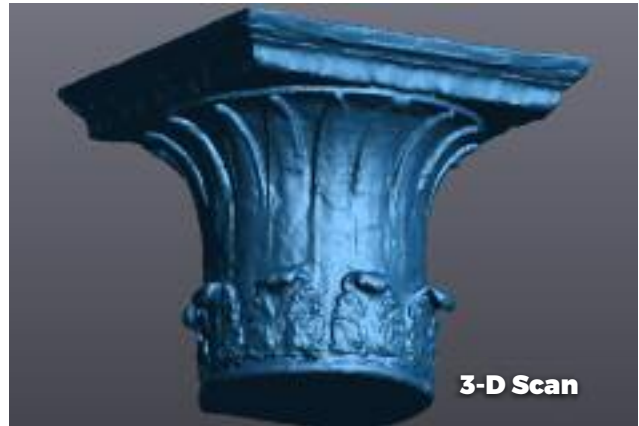
**3-D Scan**

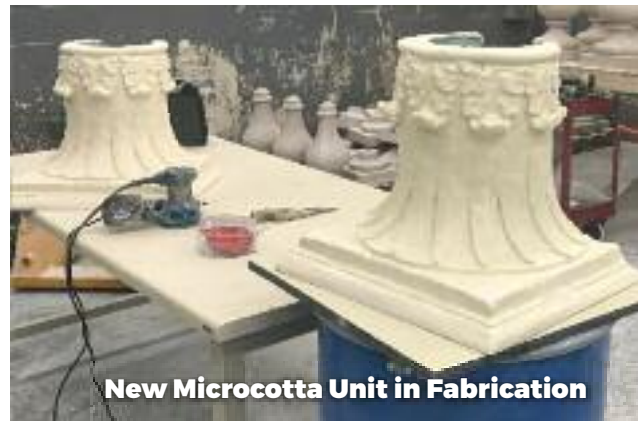
**New Microcotta Unit in Fabrication**

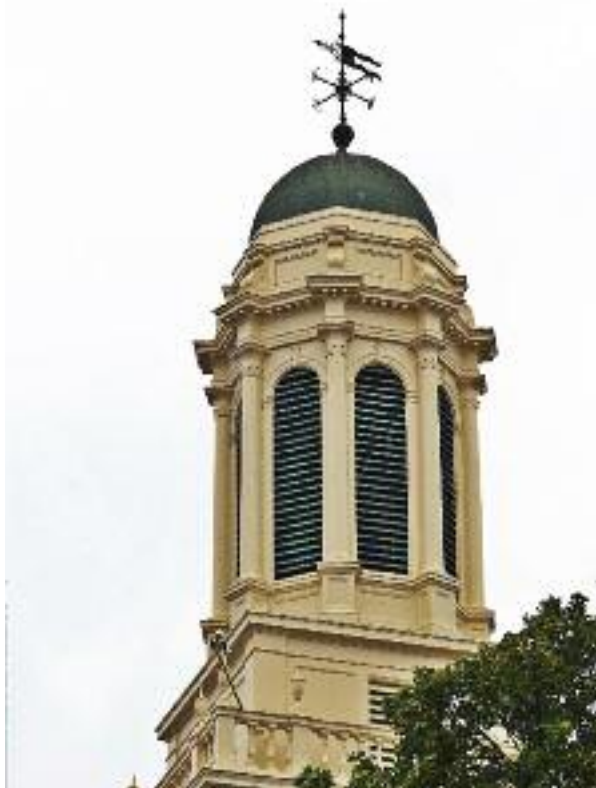
**Completed Cupola**  
Photo Courtesy Berkshire Eagle

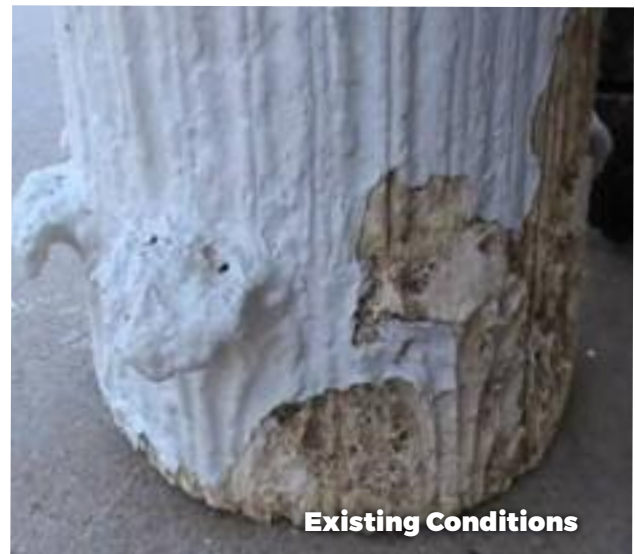
**Existing Conditions**
